Soyuz capsule suffered partial depressurization during April landing

by Jeff Foust — October 17, 2017

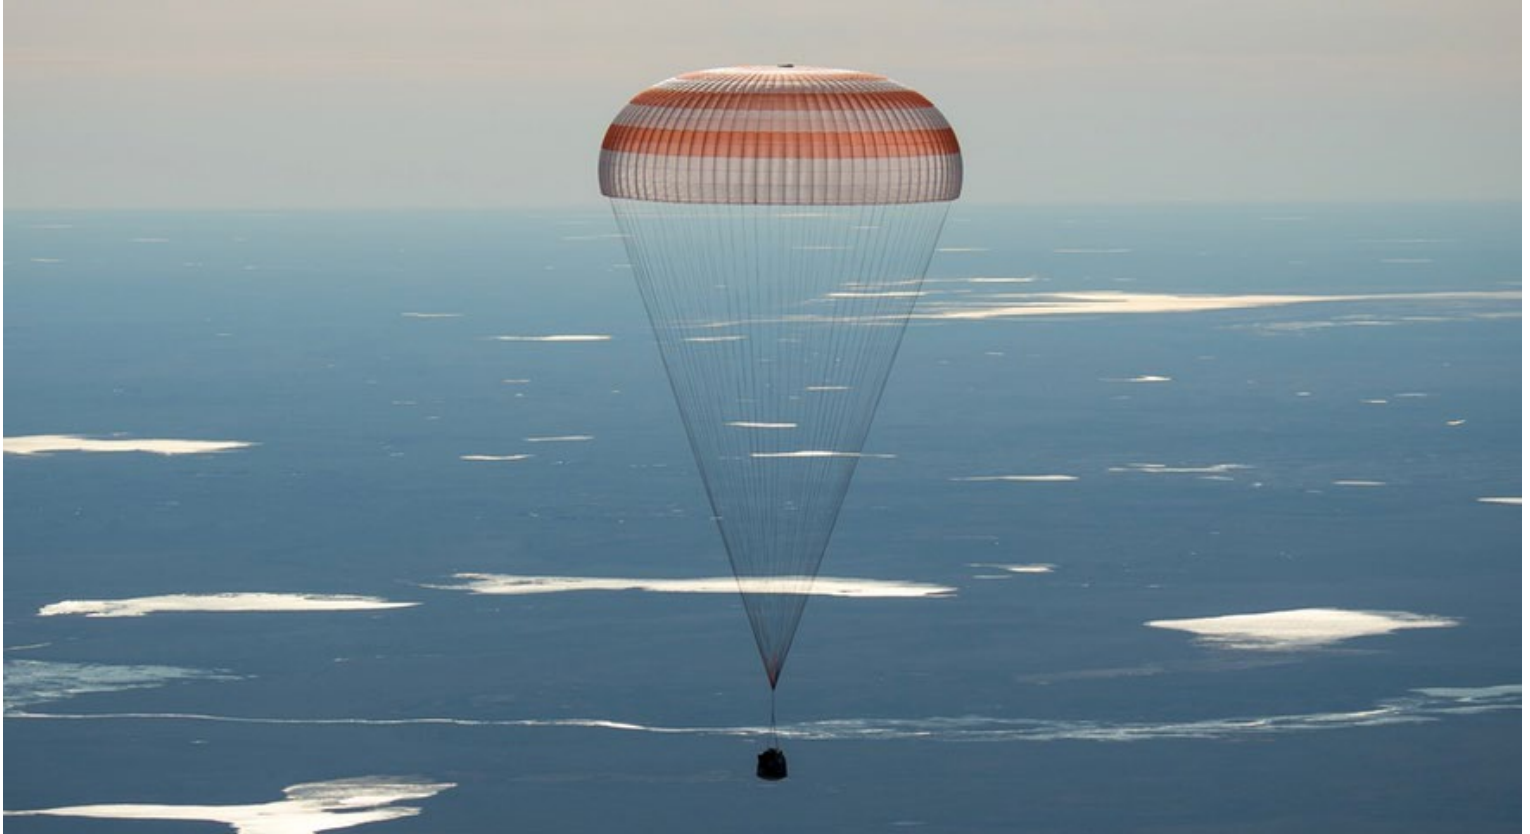
The Soyuz MS-02 capsule descends under its main parachute prior to landing in Kazakhstan in April 2017. An issue with the parachute's deployment caused a partial loss of pressurization inside the capsule. Credit: NASA/Bill Ingalls

place when the main parachute of the Soyuz spacecraft deployed about eight kilometers above the landing site in Kazakhstan. A buckle that is part of the parachute system struck the capsule.

“The buckle struck a welding seam and, as a result, there was a depressurizing event that resulted in some air escaping the capsule,” he said.

At a June meeting of Stafford’s committee with its Russian equivalent, Stafford said that Russian officials believed that the way the parachute was folded inside the Soyuz may have caused the buckle to hit the capsule during deployment, with the angle of the spacecraft during reentry also possibly playing a role.
